TEXAS OFFICIAL WOOD DESTROYING INSECT REPORT

1A. Spectra Pest Services Name of Inspection Company 1B. 13699 SPCB Business License Number
1C. 6310 Millwood Court Address of Inspection Company Arlington City TX State 76016 Zip 817-492-0161 Telephone No.
1D. Eric Evans Name of Inspector (Please Print) 1E. [X] Certified Applicator (check one) [] Technician

5. Multi-Family Apartment Complex

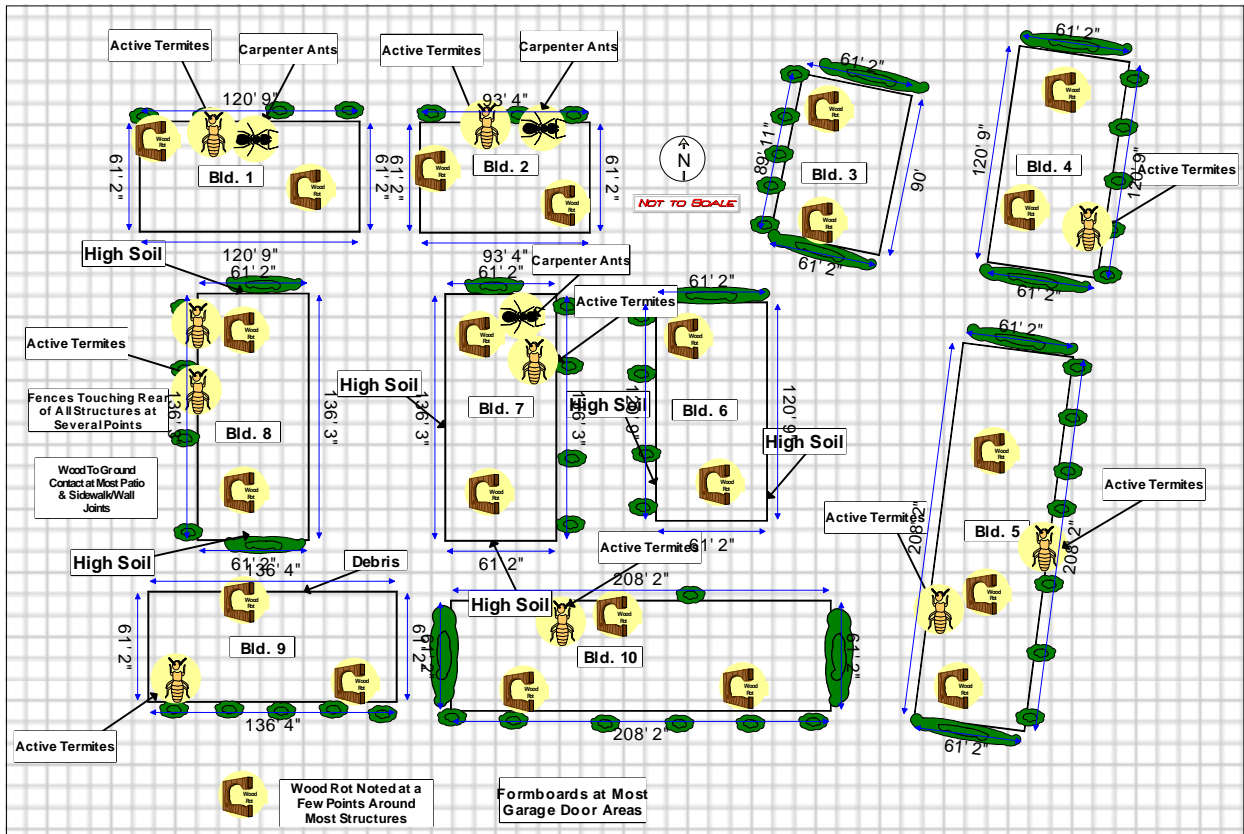
Diagram of Structure(s) Inspected

7B. Conducive Conditions include but are not limited to:
[X] Debris under or around structure (K) [X] Footing too low or soil line too high (L) [X] Wooden Fence in Contact with the Structure (R)
[] Planter box abutting structure (O) [] Wood Pile in Contact with Structure (Q) [] Excessive Moisture (J)
[] Insufficient ventilation (T) [X] Formboards left in place (I) [X] Heavy Foliage (N)
[X] Wood to Ground Contact (G) [X] Wood Rot (M)
[X] Other Plumbing slab penetrations

8F. Explanation of signs of previous treatment (including pesticides, baits, existing treatment stickers or other methods) identified:
8G. Visible evidence of: Active Infestation has been observed in the following areas: Building 1,2,4,5,6,7,8,9 & 10

If "Yes" specify corrections: Clear vegetation, high soil, debris, form boards

Specify reason: Preventive treat slab penetrations and any non corrected conducive areas
